Case Studies

# Conveyor Feed and Reject Bin

# Tailings Pipe Line

# **Spirals Feed Pump Pipe Work Monitoring Case Study**

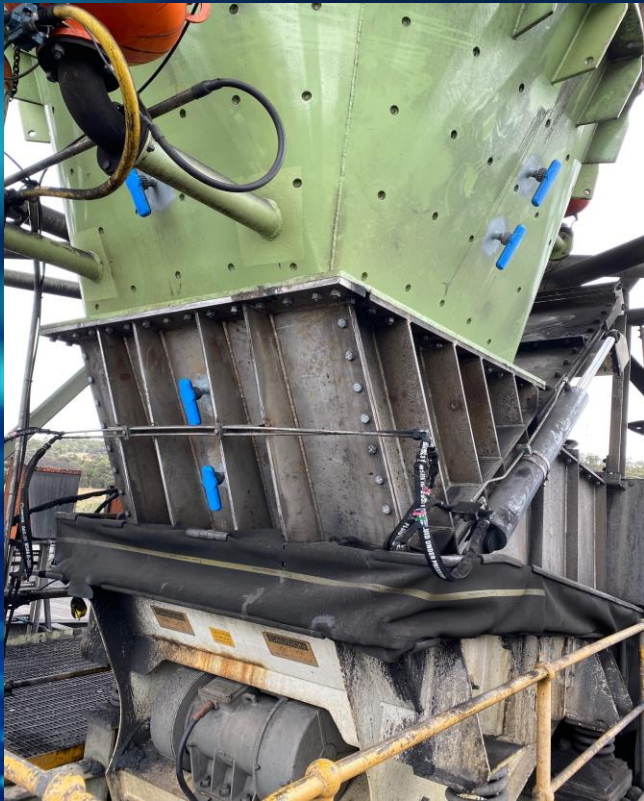
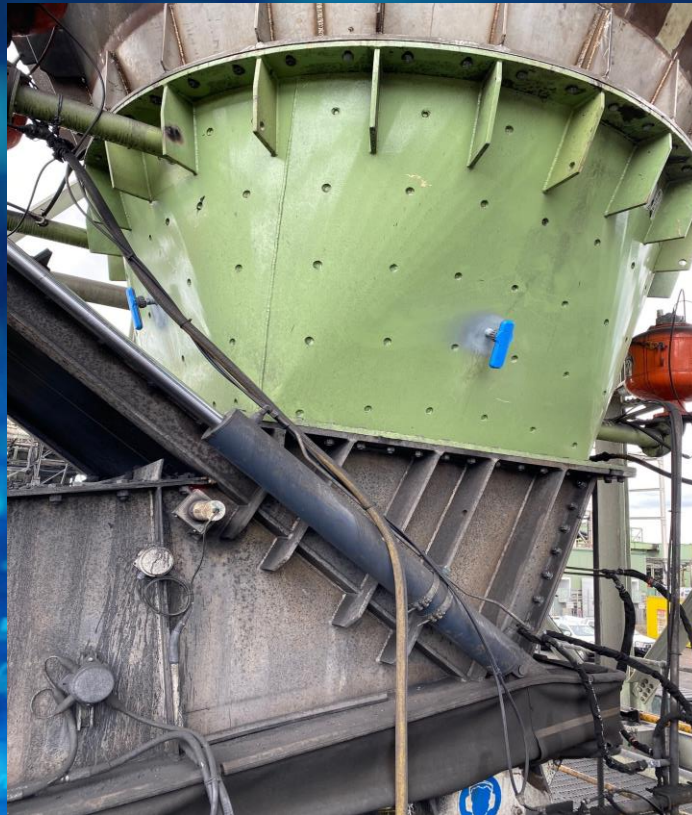
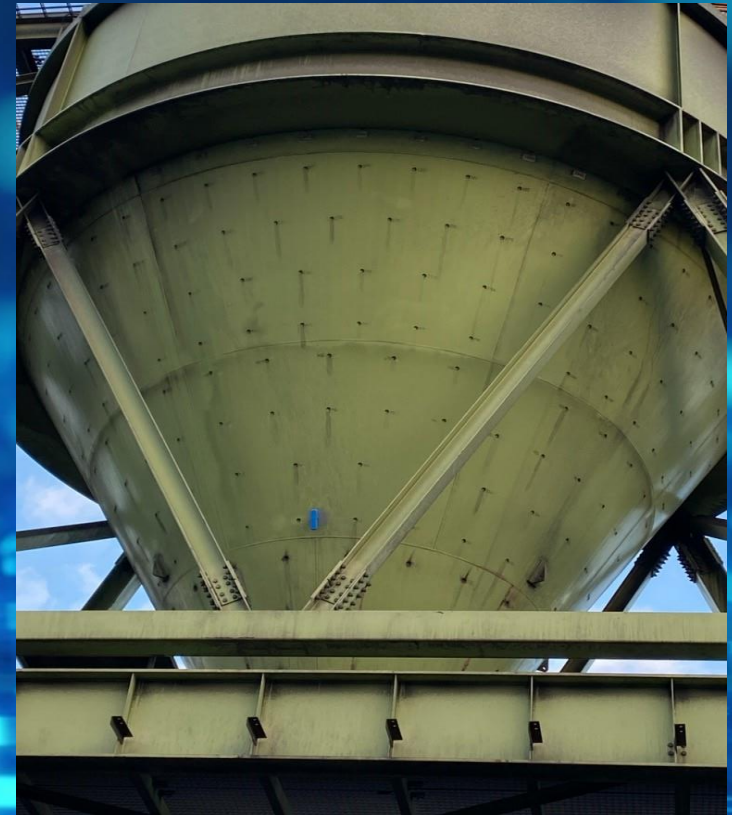
# Conveyor Feed and Reject Bin

**Monitor 35mm internal wear lining of the conveyor feed and reject bin. 60mm wear probe installed at high wearing choke points. Known high abrasive wear locations.**

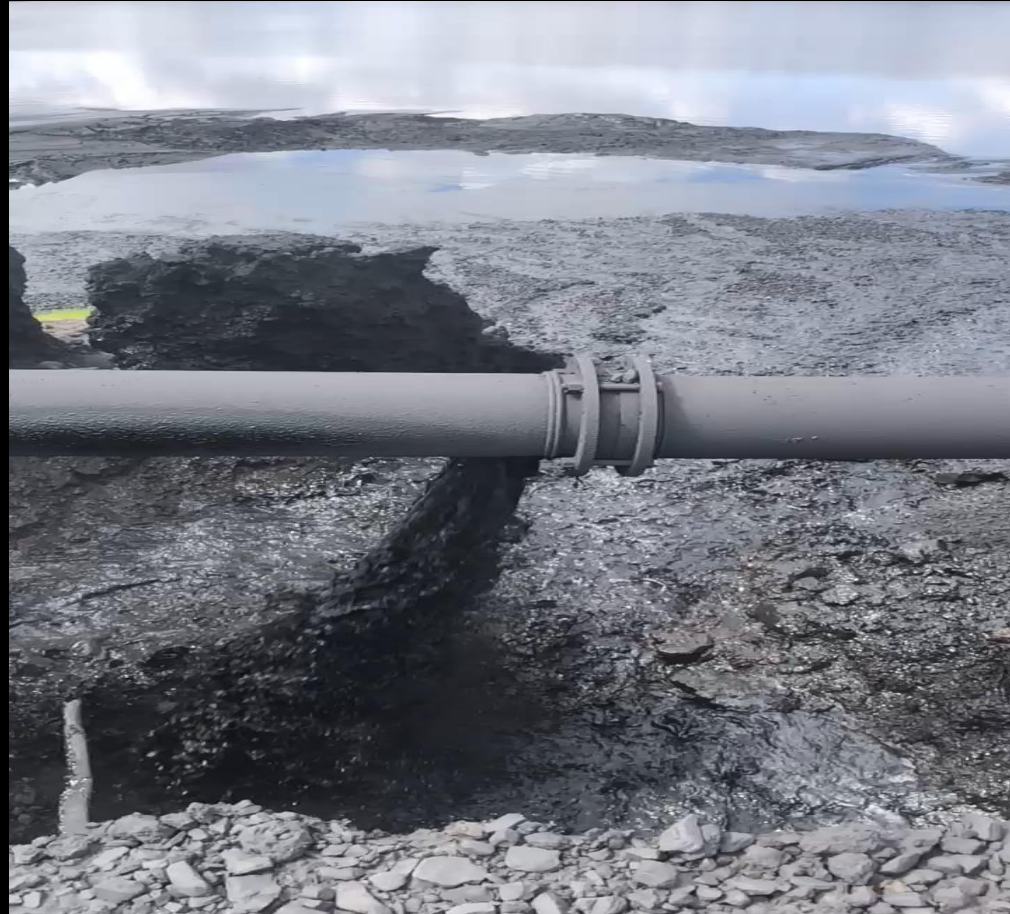
# Tailing Pipe Line Failure

Coal mining product reject tailing pipeline. 2 x 5km x 280mm PN25 HDPE in 20m flange spools. No budget for manual inspections. Pipe spools lasting 6 months. Risk of Environmental incident. CHPP (Process Plant) unplanned shut down risk on pipe failure.

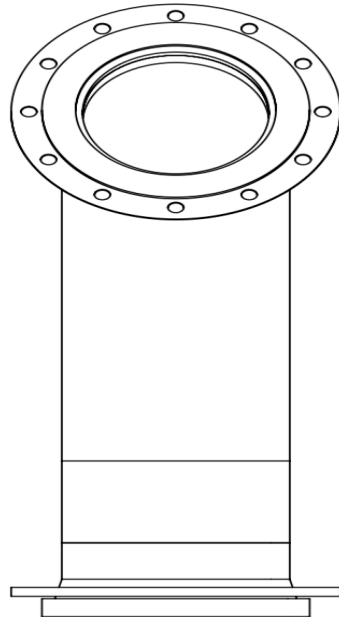
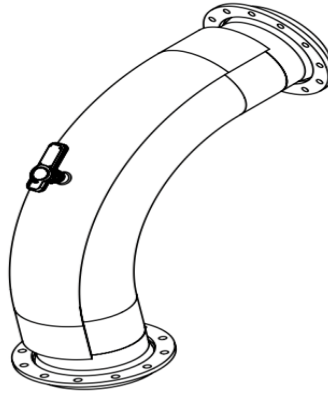
# Spirals Feed Pump Pipe Work Monitoring Case Study

- **Monitor 90deg sweeping bend 315mm SDR11 HDPE. Extra layer welded onto the outer bend (30mm) to extend wear life. Total thickness monitored 60mm.**
- **60mm wear probe installed on outer point of the bend. High wear area.**

ITEM NO.	PART NUMBER	QTY.
1	315MM - HDPE PIPE PN16	1
2	315MM STUB FLANGE - SDR11 PE100	2
3	315MM GAL BACKING RING - TABLE D	2
4	SENSOR	1
